Lucas 2MC Capacitor Warning

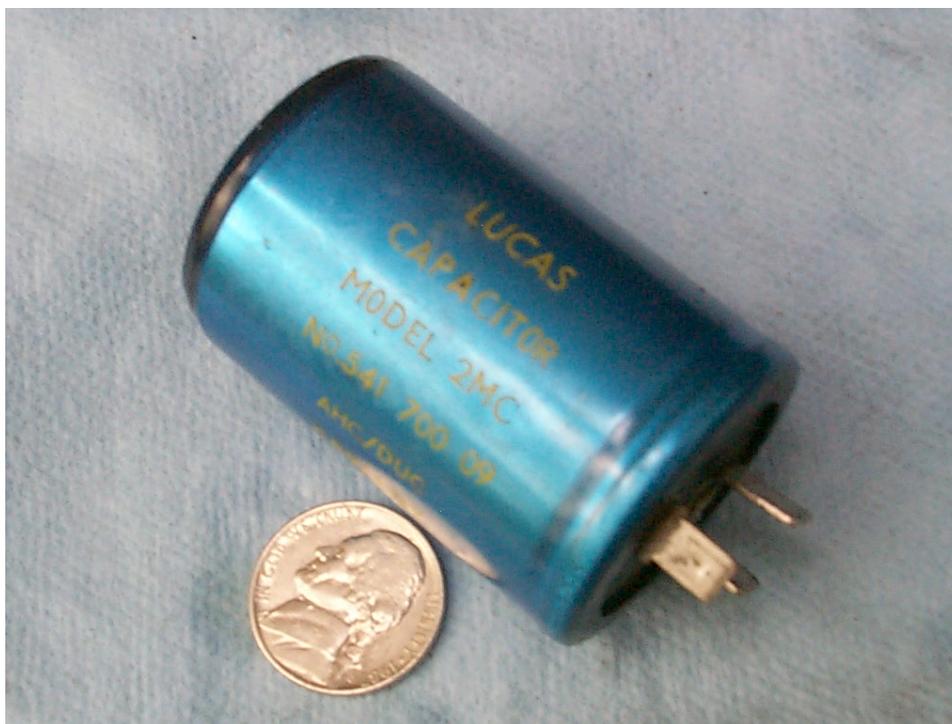
Part of that preparation included removal of the battery and battery tray. The battery, which was required for proper functioning of the battery/coil ignition, was replaced with the Lucas version of the "battery eliminator", otherwise known as the 2MC capacitor. The 2MC was a large electrolytic capacitor that connected to the harness in the same manner as the battery, but weighed about 1/100th of the battery.

When a 2MC works properly it can disguise the fact that the battery is dying until the owner is left walking. And when the 2MC starts to fail the owner may buy several batteries before discovering the actual problem. When you add to this electrical game of hide-and-seek the fact of its inevitable failure, you may decide that having a 2MC in your electrical system might simply be more pain than it's worth. Therefore, if your bike is equipped with the bright blue Lucas 2MC capacitor that was fitted as original equipment, in my opinion the best thing you can do is to disconnect the RED wire from the positive terminal. After disconnection, the RED wire should be insulated with heat shrink tubing to prevent accidental re-connection.

If you decide to replace your 2MC and keep your motorcycle completely original, then it's very important that you get a freshly manufactured unit. The ageing process that causes the problem happens regardless of whether the capacitor is sitting on a stock room shelf or installed on a motorcycle. In other words, a "new old stock" capacitor could be "bad" even though it was still untouched and in the box. If you are unsure of the quality of the capacitor your local bike shop has, then you can look for a 4500-microfarad electrolytic capacitor rated at 30V from an electronics supply house.
